Survey Report

Ref: St Kevin's Church – Keash, Ballymote, Co Sligo.
(Hereinafter referred to as the Property)

This Report relates to a request for a roof condition inspection report on St Kevin's Church Keash.

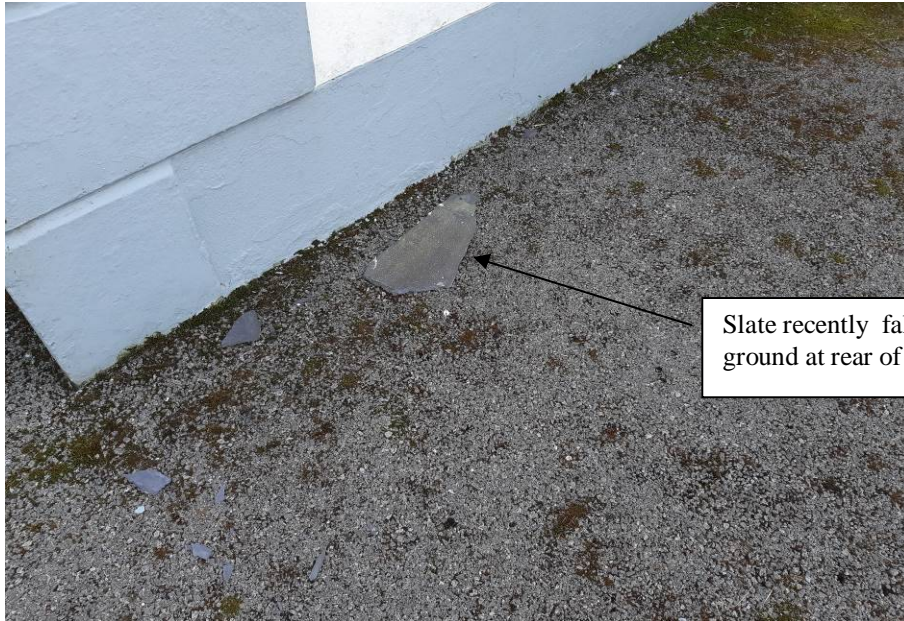
From examination of the roof external I note that Slates have become dislodged at various locations around the roof and I note that 2 have recently fallen to the ground from near the apex of the roof. While there are two areas to the rear of the roof where slates are in imminent danger of falling to the footpath below. This side of the church should be sealed off to the public until repairs have been carried out.

The fact that slates are falling from the roof at this stage would indicate that there is a health and safety issue here and it is impossible for an Engineer to indicate specifically which individual slates and how many are at risk from falling to the footpath.

It would be a logical assumption that this is the beginning of a series of slate failures as generally when one or two slates break away more follow particularly during and after wind events when age related fracture weaknesses propagate throughout the slates from nail noles , especially when they were previously disturbed and re-seated.

The general condition of the slates on the roof and an examination of the slates that have already fallen indicate this is the case. At 210 years old this is to be expected.

The only practical option I see here from an economic and structural point of view would be to remove the slates ,roof covering, battens and rafters. Treat and repair the Kingpost trusses where required.

Re slate with a quality natural slate. Re-using the existing slates would not be feasible as when disturbed the slates form micro cracks which cannot be seen during the re-slating process and would lead to a shorter lifespan than a new unstressed natural slate.

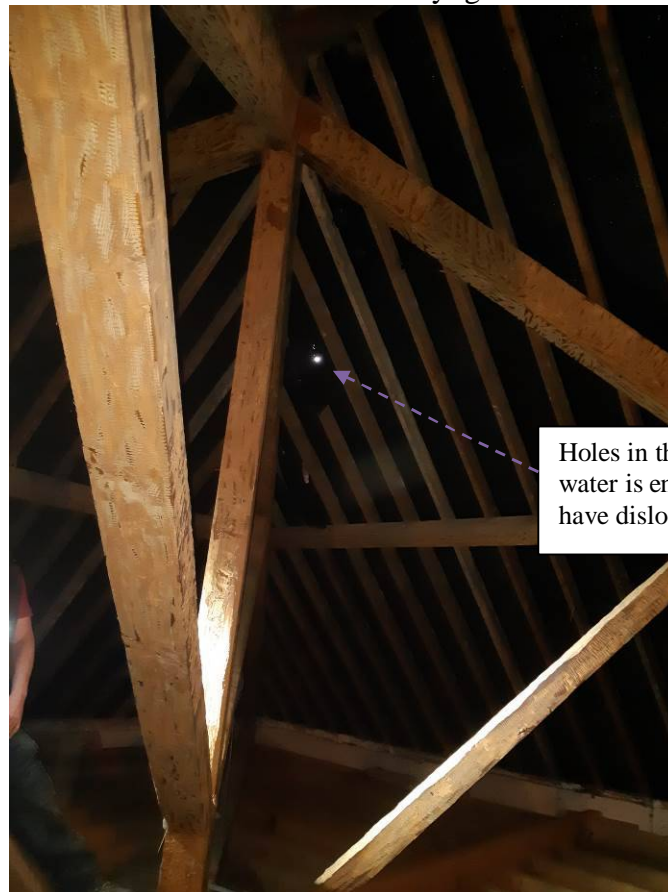
There are several locations where rainwater is leaking through the roof particularly at the valley locations. From inside the roof structure daylight can be seen in 4 locations.

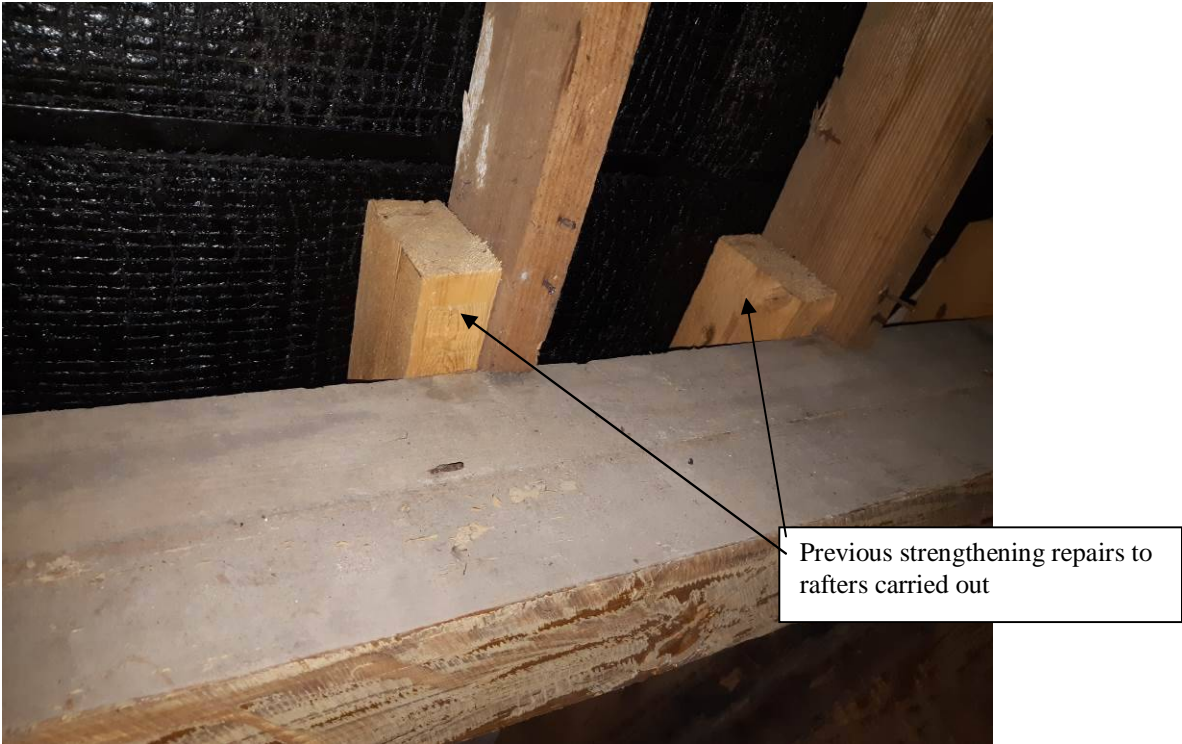
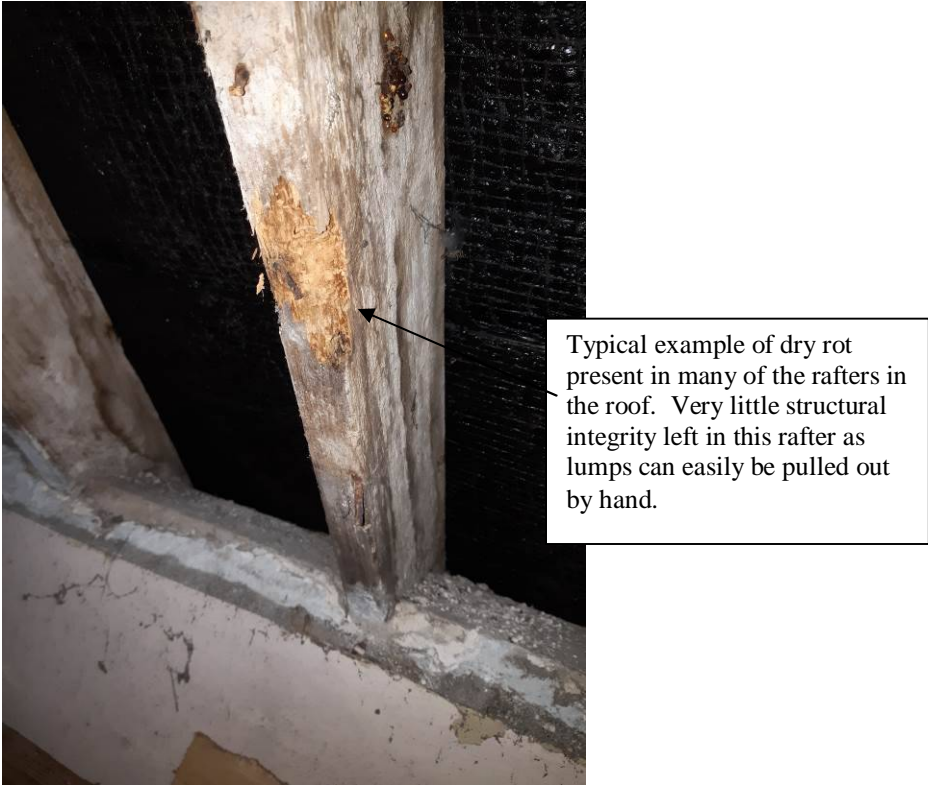
The rafters have been repaired in a few locations – again probably at the last renovation works. I note that there is a considerable extent dry rot near the base of the common rafters to the extent where lumps can be pulled out of the rafters by hand with little effort. The timberwork throughout the roof was found to have a heavy infestation of

woodworm (*Anobium punctatum*) with approx 20 % of roof members have been structurally undermined and will have to be removed and replaced by similar timber.

Rebuild the roof carcasse with new pressure treated rafters, ridge board, battens wall plate and roofing membrane. Put on a new cedar fascia. Treat, plate and repair the kingpost trusses. Re seat the gutters and rebuild the fascia backing.

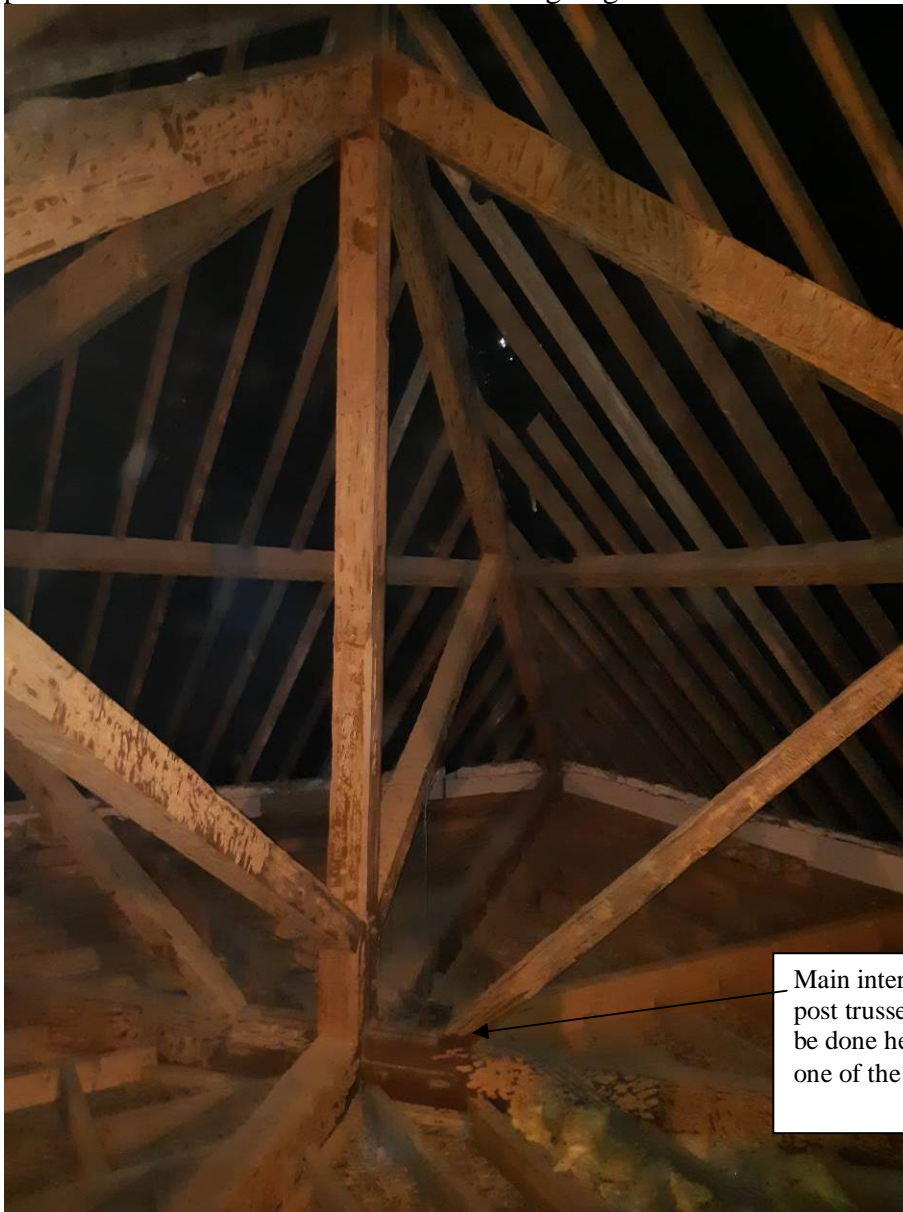
The Kingpost trusses and Purlin were stripped of paint with a layer of the outer surface hacked off. This was probably done to facilitate protim treatment for woodworm at the last renovation.

There is evidence of recent woodworm attack in the trusses. These trusses will need to be treated again with a strong application of wood preservative. The trusses and Purlins are largely intact and generally structurally sound save for a limited area where some steel plating would need to be carried out along with the replacement of support struts in 3 of the trusses where these struts have weakened due to woodworm activity over the years.

The Joint where the crossing kingpost trusses meet at the centre of the church will need to be plated and bolted for structural soundness going forward.

Where the purlins are supported on the gable walls the ends of these purlins will need to be exposed, treated and covered in damp proof membrane to prevent further decay.

The state of the supporting woodwork in general i.e. the kingpost trusses and Purlins is reasonable and has 90% of structural integrity intact and are salvageable with some plating, localised replacement of struts and treatment with strong wood preservative..

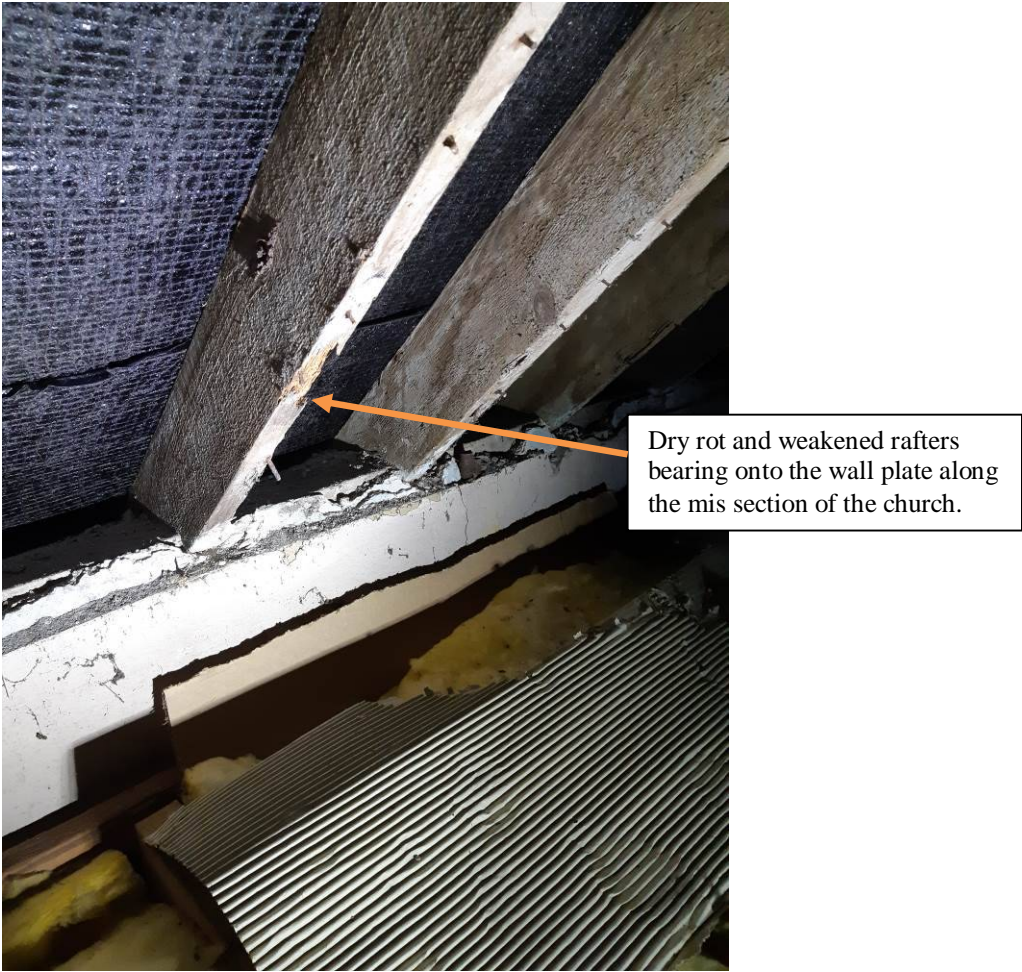
However the rafters and slate work is a different story. These are beyond reasonable repair and have a relatively short lifespan left I would say 3 to 5 years at best.

The stage has been reached where slates are breaking away from fastenings and are sliding from the roof to the ground below. This will become more frequent in the short term.

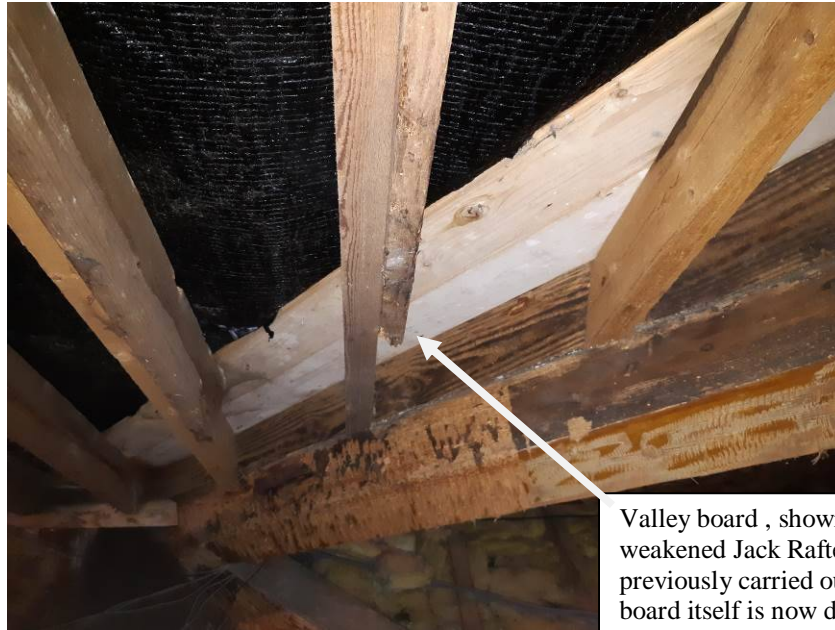
The photo above shows the underside of the valley where leaks regularly occur. The timber here is in an advanced state of Decay. Previous repairs show the extent to which the rafters had to be cut back. A similar process would have to be carried out on many of the rafters along the wallplate level of the roof.
